December 3, 2010

Re: Preliminary Karst Condition Assessment
Horse Creek Wind Farm
Clayton, Jefferson County, New York
Terracon Project No. J2105236

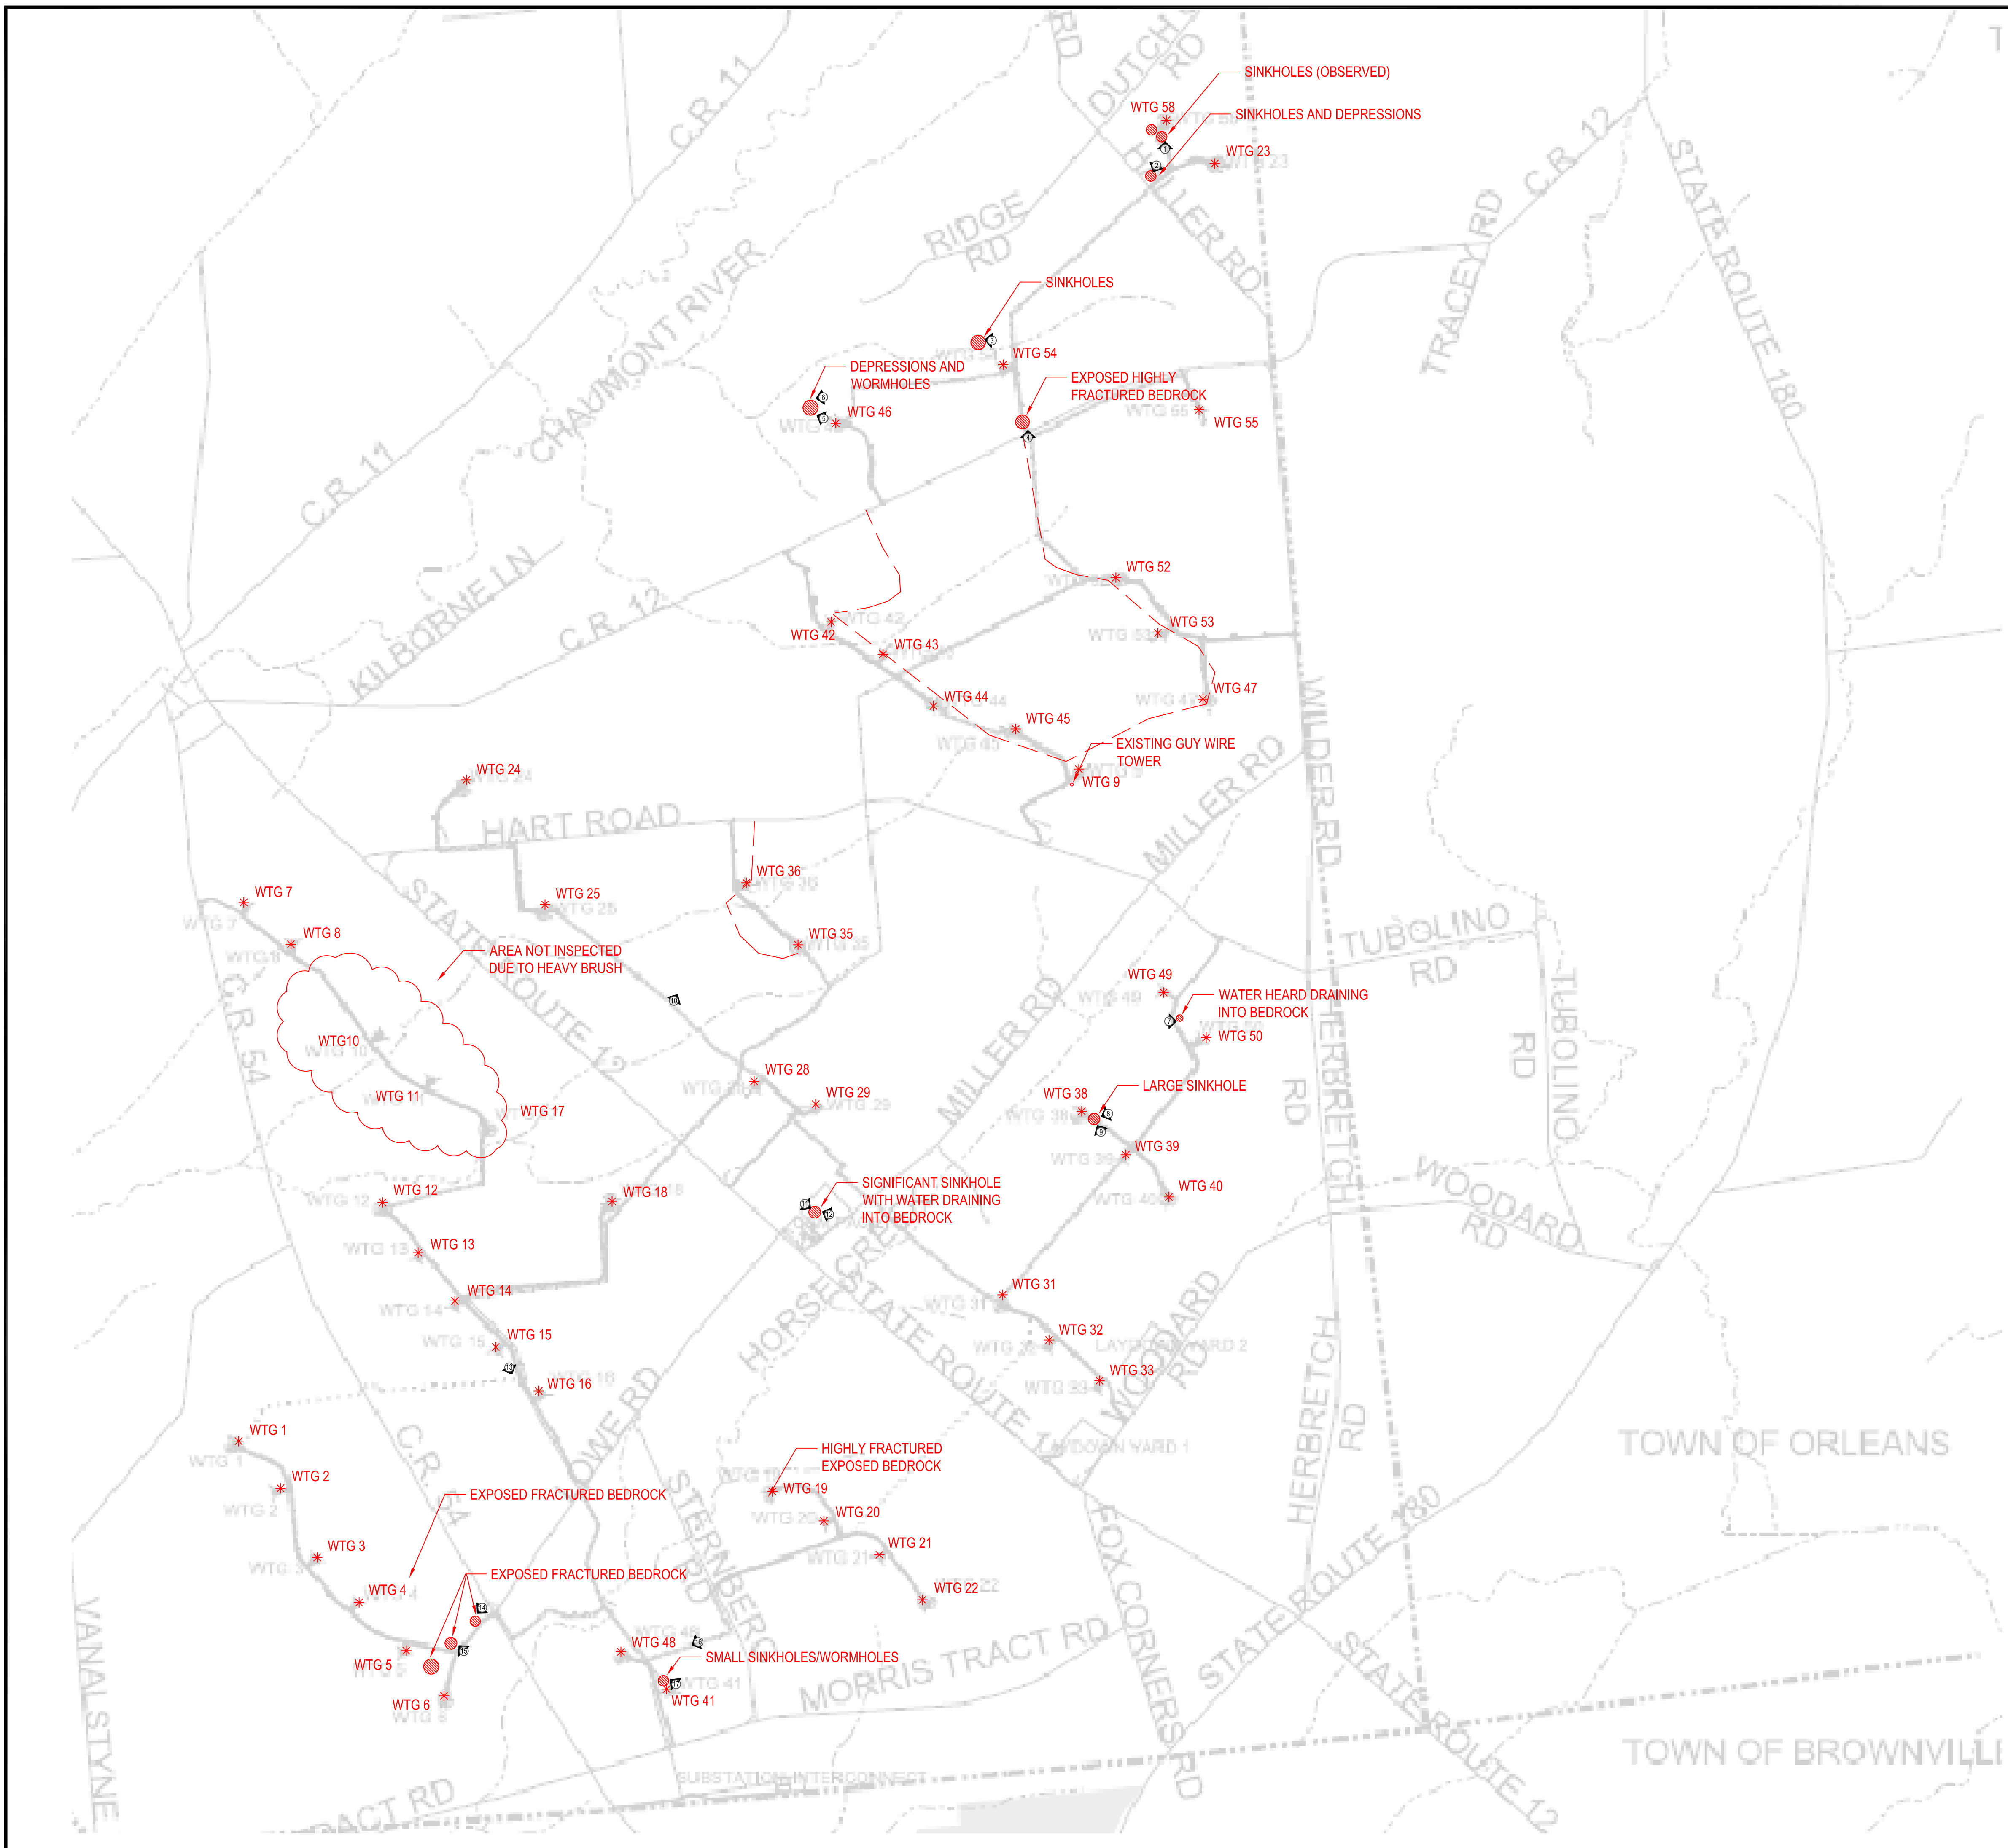
DESIGNED BY:	RWO
DRAWN BY:	RWO
APPVD. BY:	JGS
SCALE:	NOT TO SCALE
DATE:	11-30-10
JOB NO.:	J2105236
ACAD NO.:	J2105236.002
EXHIBIT:	A-1

Visual inspection was completed by walking routes of proposed access roads from their intersection with existing roadways to each wind turbine. Observations regarding the presence of sinkholes, depressions, exposed bedrock, or other anomalies indicative of Karst conditions were noted during the walk along the proposed access roads and at proposed wind turbines; however, some access roads were not traversed because of the presence of wooded land, wetlands, or fencing. The attached Exhibit A-2 indicates the wind turbines investigated and the walking route, if different from the proposed access route. Exhibit A-1 also shows areas of anomalies observed during the reconnaissance.

During the site reconnaissance, depressions and sinkholes were observed proximal to wind turbine Nos. 5, 46, 38, 41, 46, 54, and 58. Depressions and sinkholes were also observed along the proposed access road between wind turbine Nos. 49 and 50, 23 and 58, and from Depauville Road to wind turbine Nos. 5 and 6. The sinkholes ranged in size from a few inches to over 10 feet in diameter and extended to depths ranging from about 1 to 4 feet.

At this time, we recommend that a geophysical survey be completed to further evaluate the areas of concern (wind turbine Nos. 5, 6, 38, 41, 48, 49, 50, 54, and 58) identified during the site reconnaissance. However, because of the risk of additional karst features at other turbine locations that did not indicate surficial anomalies, consideration should be given to completing geophysical surveys at each turbine location. The geophysical survey should include electrical imaging (EI) to provide a cross-sectional image of the subsurface conditions to a depth of about 50 feet below existing grade. The EI survey is effective in identifying solution cavities or voids, which are not propagating to the ground surface. Following the EI survey, we recommend that soil borings and bedrock coring be completed to further define the subsurface conditions. The borings would be completed at locations that exhibited abnormal subsurface conditions, as determined by the EI survey. The purpose of the borings would be to further evaluate the subsurface conditions and categorize them as they relate to long-term risk for the proposed development. The EI survey and borings will assist in evaluating these risks and providing an estimated cost for remediation. Additionally, the completed soil borings will be used to provide preliminary geotechnical engineering recommendations for the project.

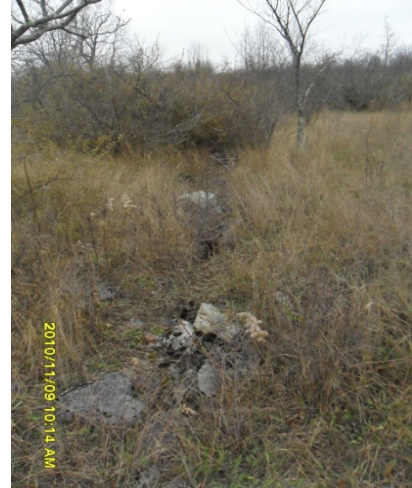
13) Typical drainage swale located throughout agricultural fields

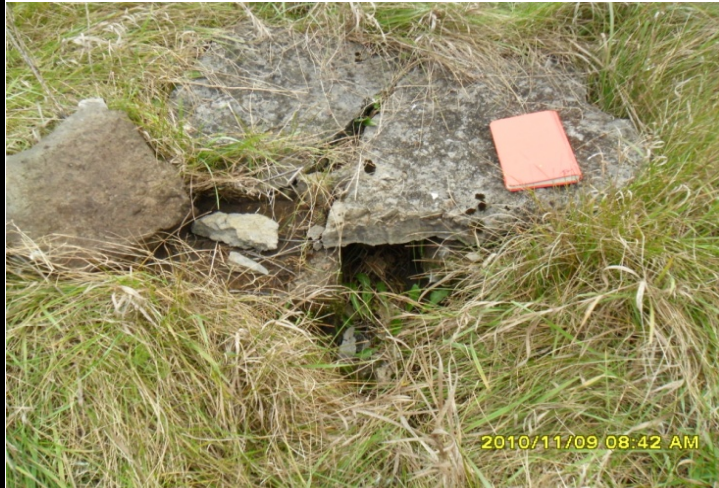
14) Exposed bedrock fracture with voids

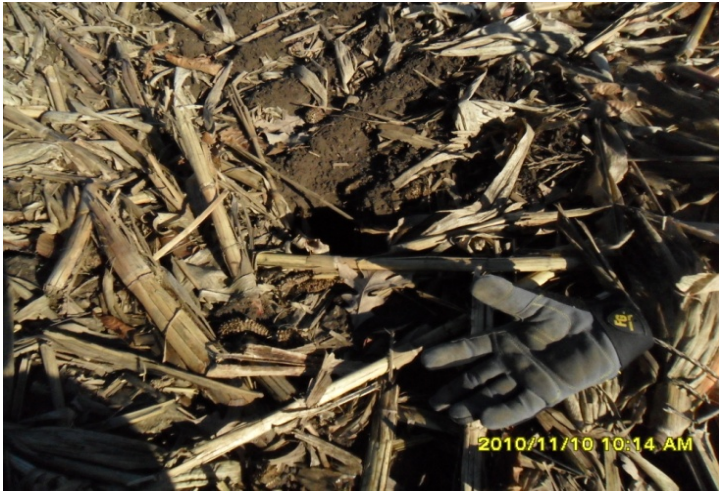
16) Exposed bedrock fracture with voids
