STRUCTURES INVENTORY & ASSESSMENT

HORSE CREEK WIND PROJECT

Town of Clayton
Jefferson County
New York

Published: December 2010

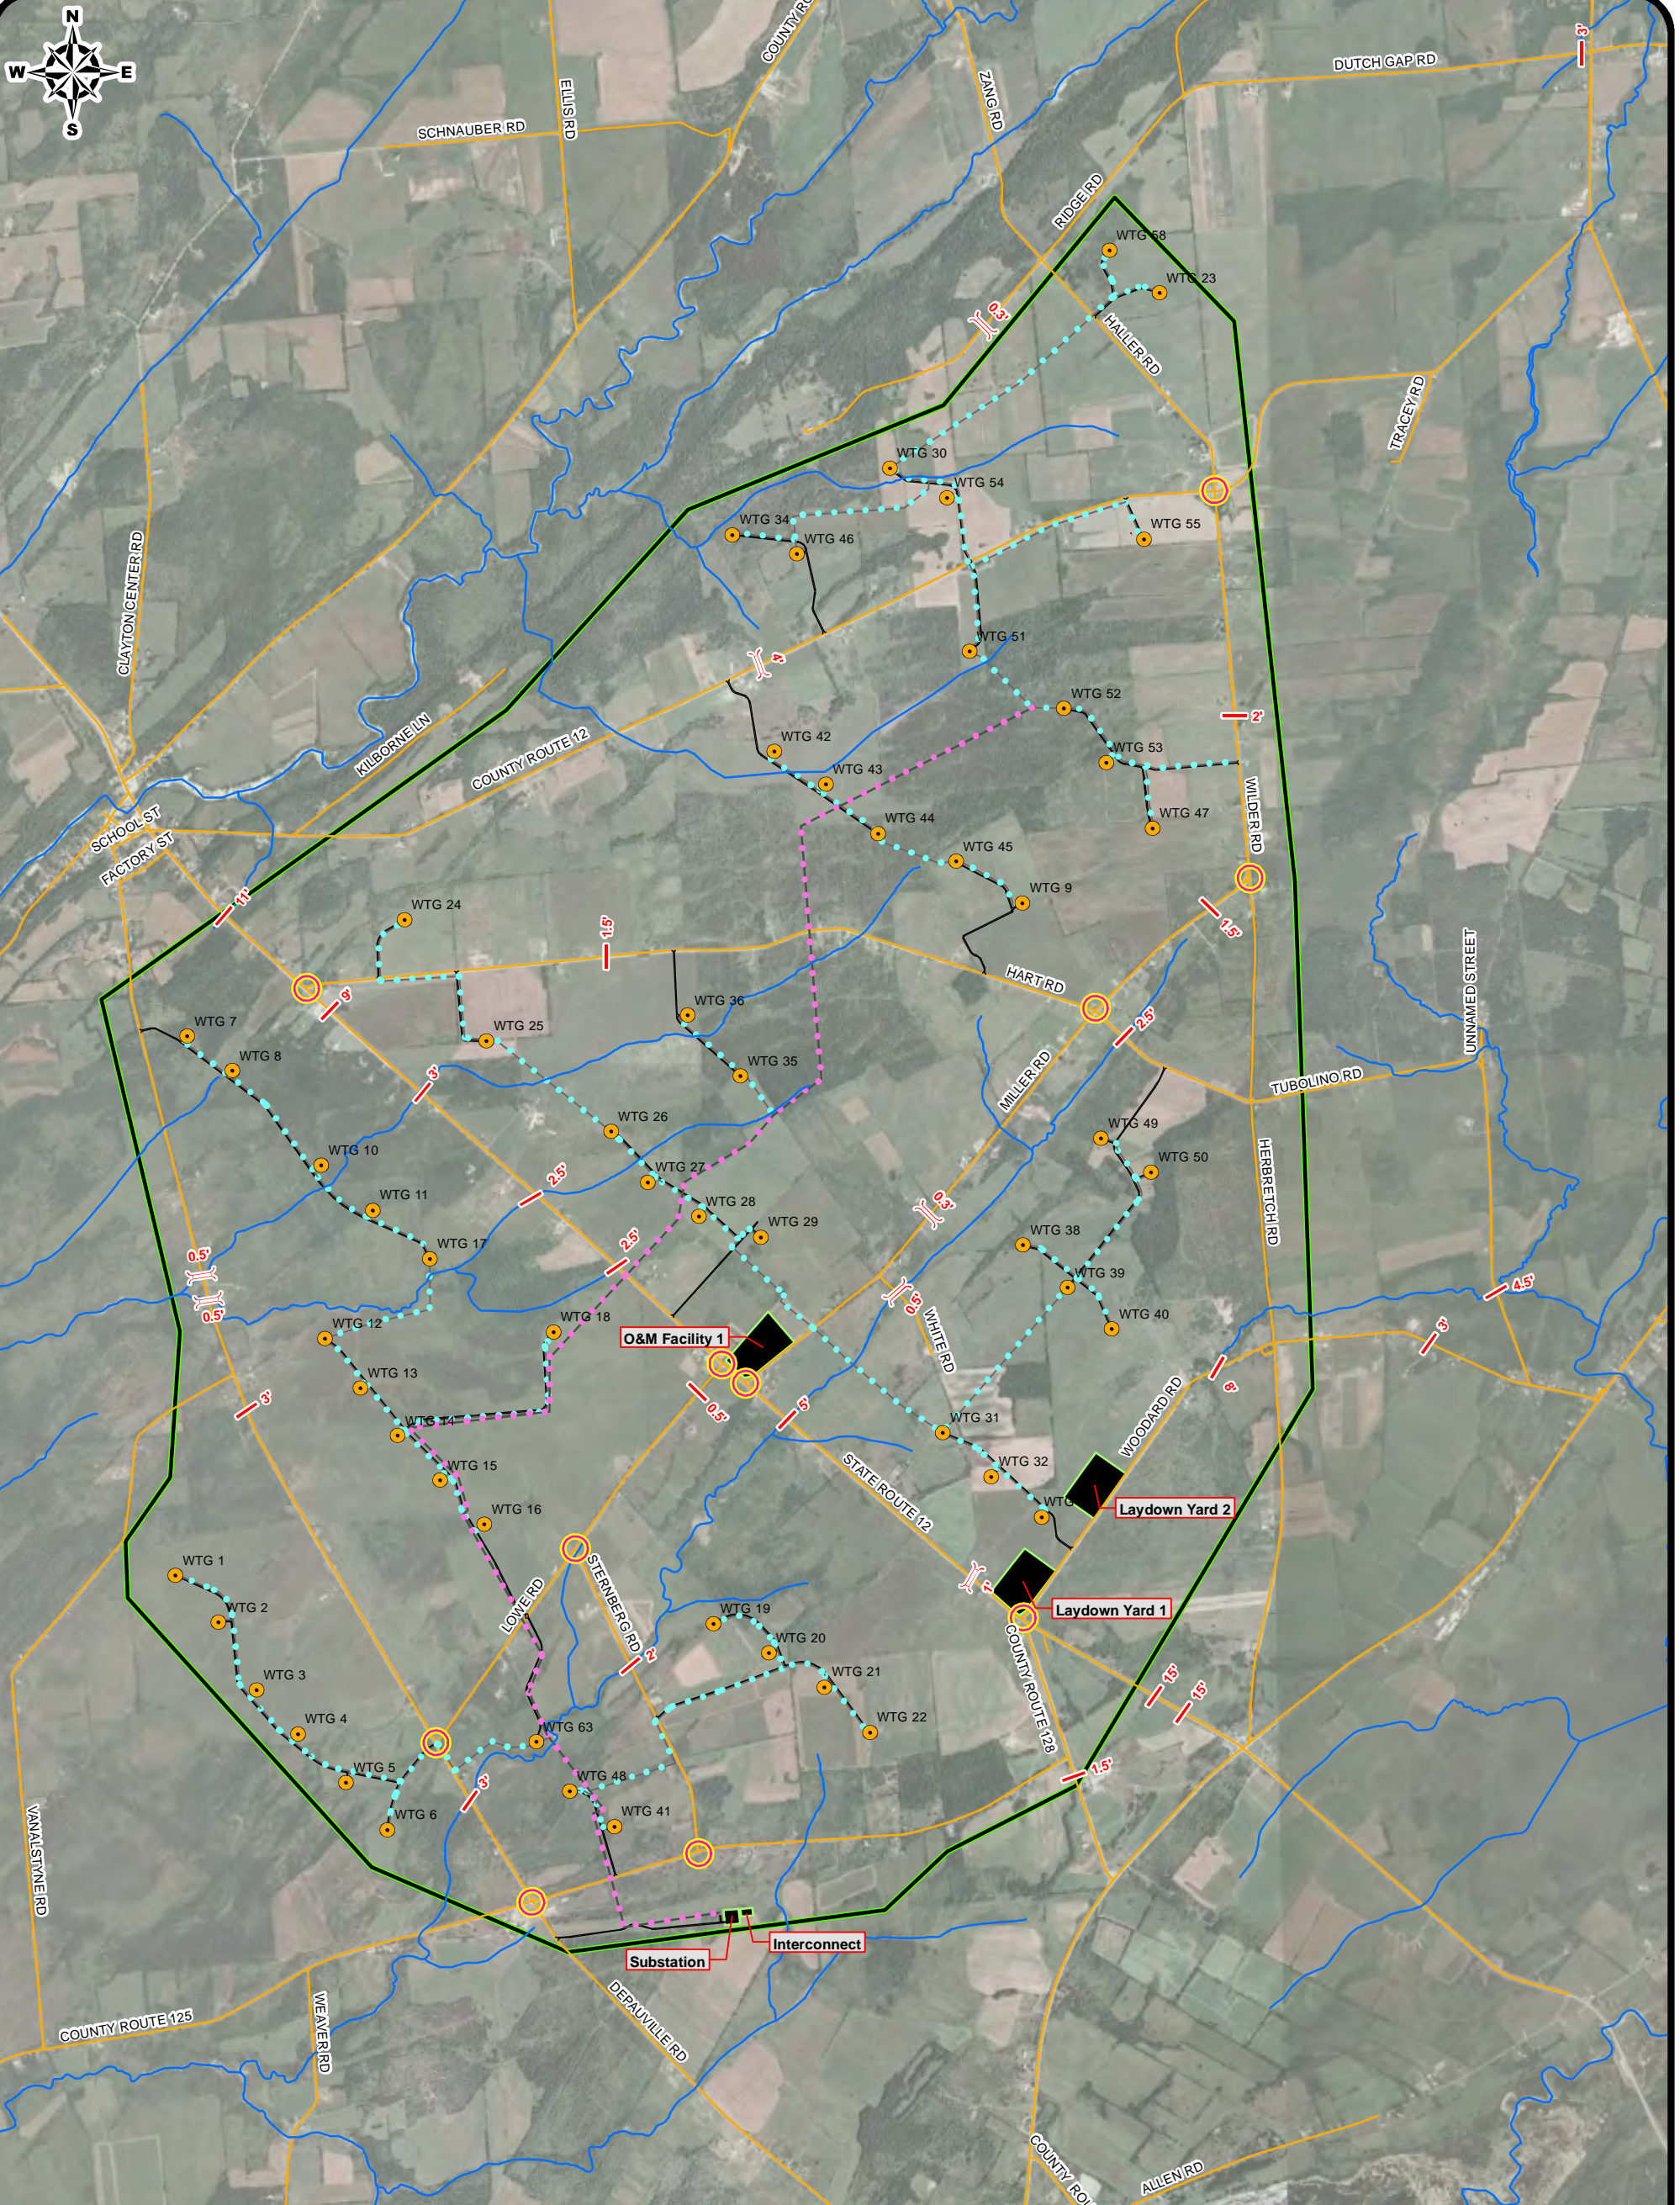
Exhibit 4: Culvert Type & Diameter

The Culvert Type & Diameter and Culvert Minimum Cover & Condition maps, Exhibits 4 and 5, present the locations of the drainage structures apparent in the field. For the purposes of this study, it is assumed that any culvert with less than 2 feet of cover may be susceptible to damage during construction activities. The inventory table in Exhibit 3 highlights any locations with concerns in regards to insufficient cover, roadway width, and/or structure condition.

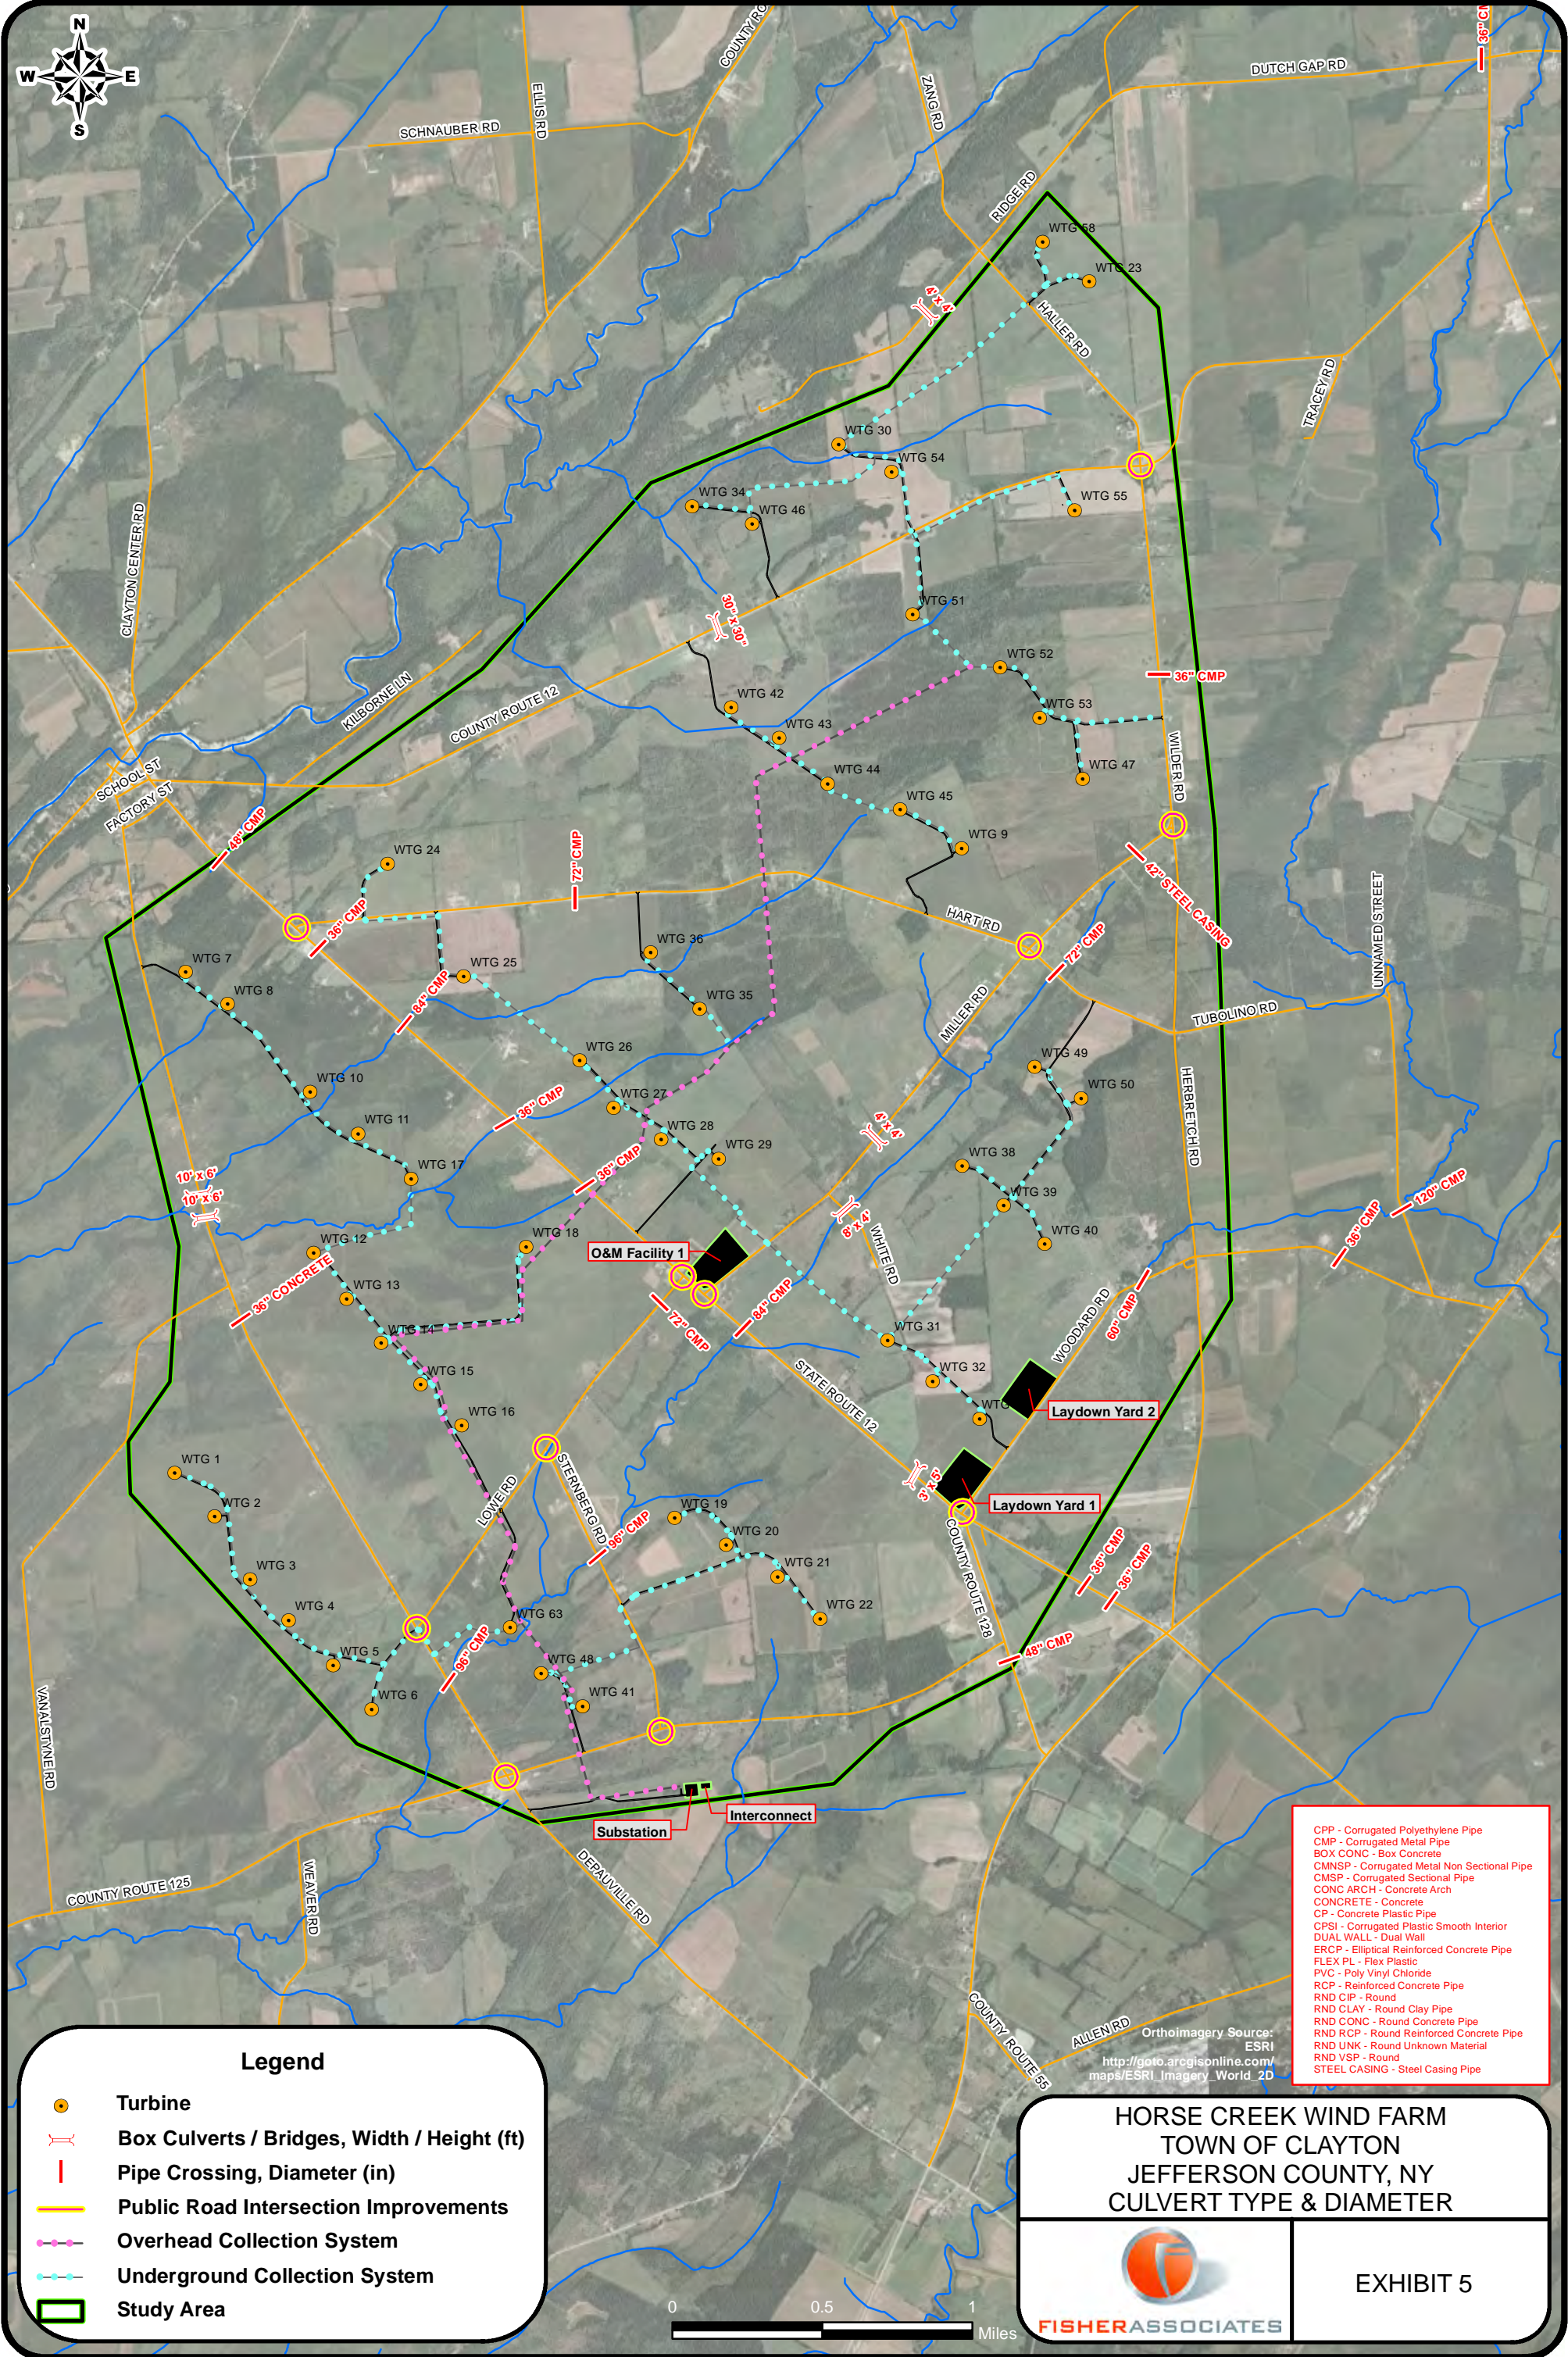
Exhibit 5: Culvert Minimum Cover & Condition

Impact – Twelve drainage pipes/culverts have been identified as having less than 2-feet of cover or are in poor condition as shown in Exhibit 5. Of those twelve, eight of them are on the proposed transportation route. These culverts may be crushed or deformed by construction activities causing construction delays, delays to local motorists, and damage to construction vehicles and/or turbine components.

Six of the eight pipes on the transportation route are in fair or good condition but have less than two feet of cover. It is anticipated that these structures could be mitigated by

The remaining three pipes on the transportation route are in poor condition and would likely need to be replaced or avoided for construction.

Mitigation – Each pipe should be evaluated during final design of the roadway improvements to determine if improvements will be necessary to accommodate the construction activities. Improvements may include:

- Additional cover over pipes,
- Reinforce pipes with bracing,
- Use bridge jumpers to clear pipes,
- Use bridge plates to distribute vehicle loading,
- Replace pipes prior to construction,
- Replace pipes during or after construction if damaged by construction activities.

replacement, adding additional cover over the pipes, or other improvement as determined in final design.
