December 3, 2010

Re: Preliminary Karst Condition Assessment
Horse Creek Wind Farm
Clayton, Jefferson County, New York
Terracon Project No. J2105236

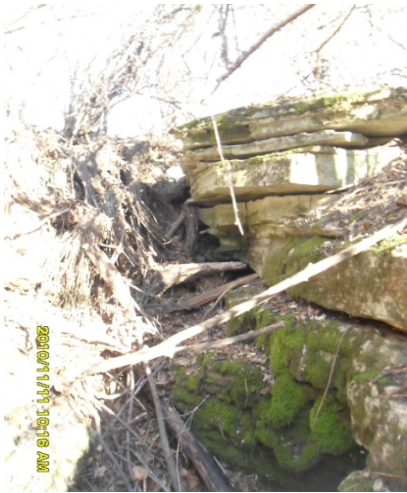
Of particular concern at the site are areas of “disappearing streams” noted at two locations during the site reconnaissance. These streams channel surface water from the surrounding farmland into the bedrock. These disappearing streams, or “drains”, have the potential to focus a significant amount of water into the underlying bedrock, increasing the rate of erosion and dissolution of underlying bedrock. Drains were observed at the planned O&M Facility No. 1 and near wind turbine No. 54. Consideration should be given to move development away from these areas.

3) 8-foot deep depression with water flowing into bedrock

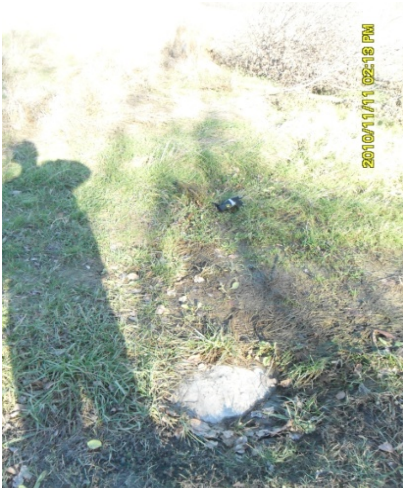
7) Exposed bedrock where significant water flow was heard

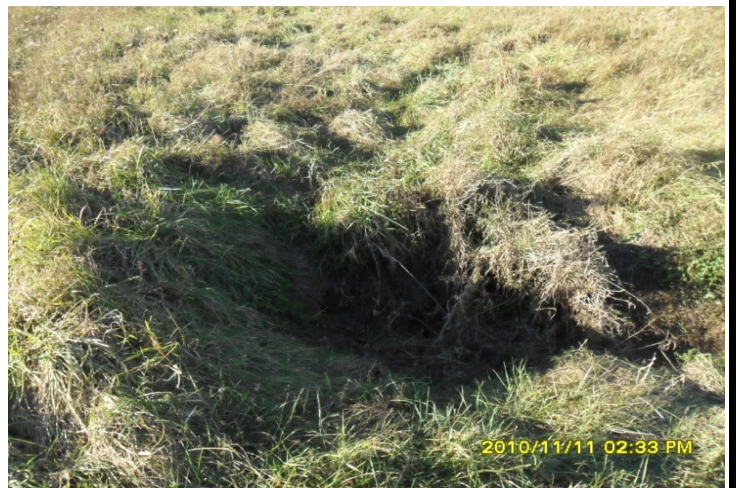
8) 4-foot diameter by 2-foot deep sinkhole

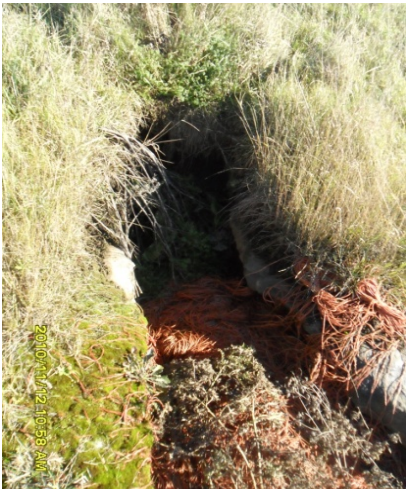
11) Large void and bedrock drain

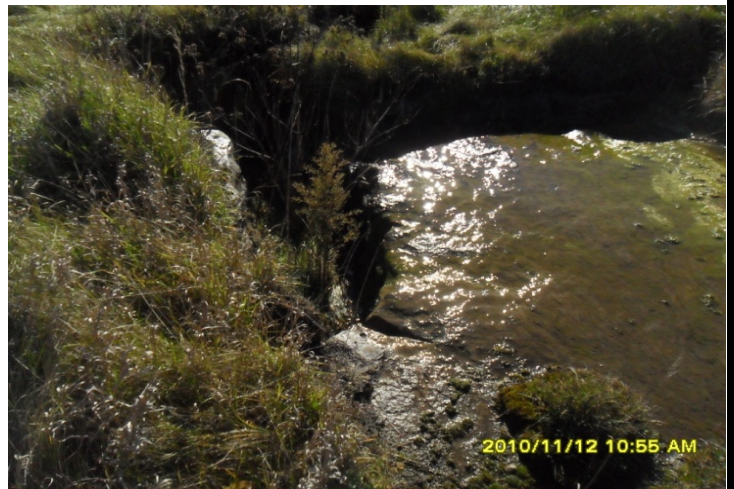
12) Large void and bedrock drain
