December 3, 2010

Re: Preliminary Karst Condition Assessment
Horse Creek Wind Farm
Clayton, Jefferson County, New York
Terracon Project No. J2105236

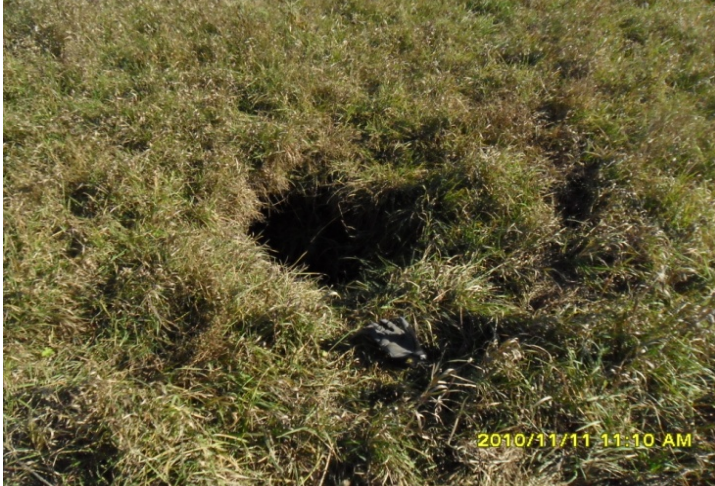
1) 16-inch diameter by 2.5-foot deep sinkhole

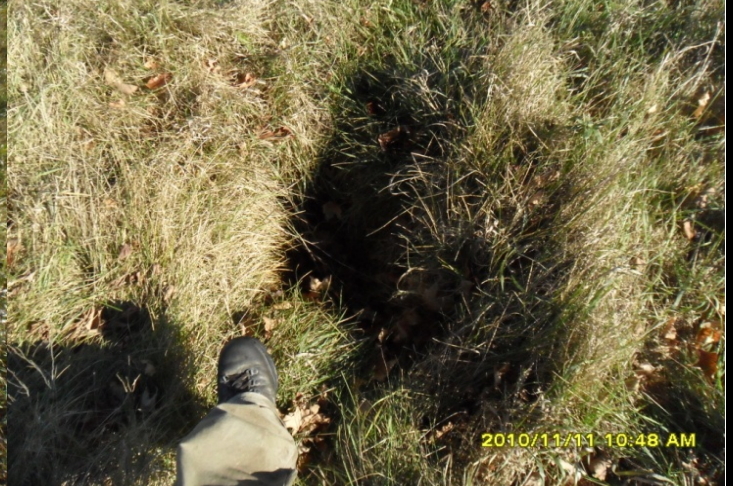
2) 2-foot diameter by 1.5-foot deep sinkhole

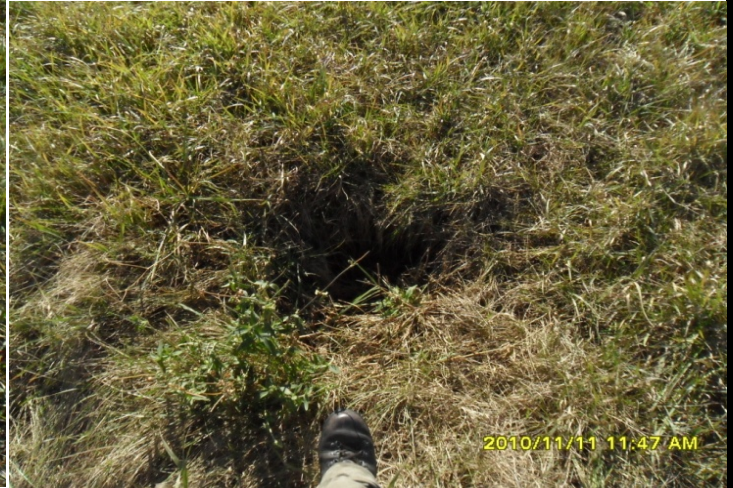
6) 2 foot diameter by 6-inch deep sinkhole

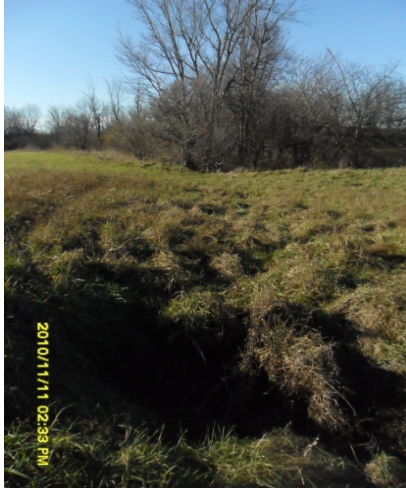
9) 10-foot diameter by 4 foot deep sinkhole

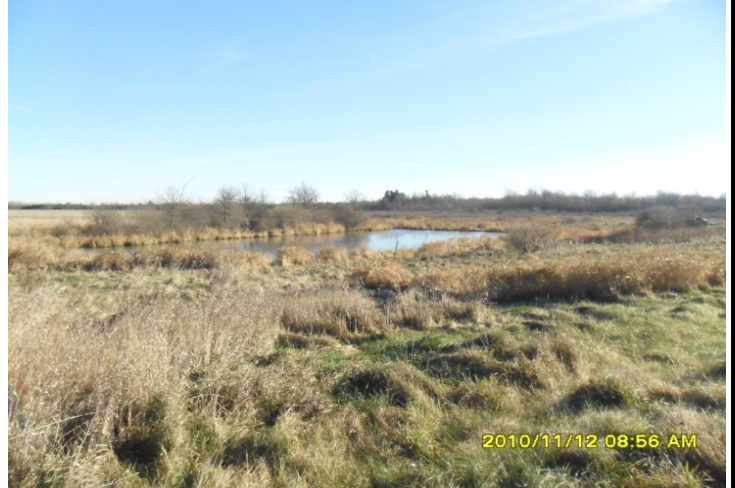
10) Pond located proximal to access drive

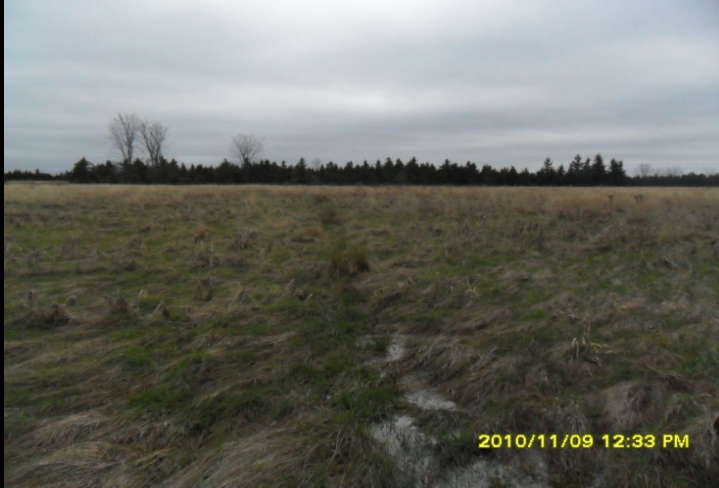
13) Typical drainage swale located throughout agricultural fields
